2018 Chevrolet Camaro V8-6.2L

#18-NA-276: Paint Wear Mark or Chip at Corner of Rocker Panel Molding from Door Over-slam Hem Seal Contact - (Sep 10, 2018)

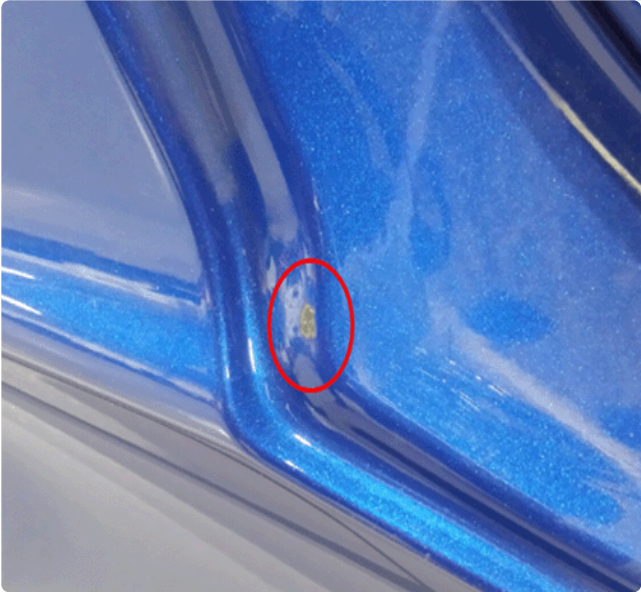
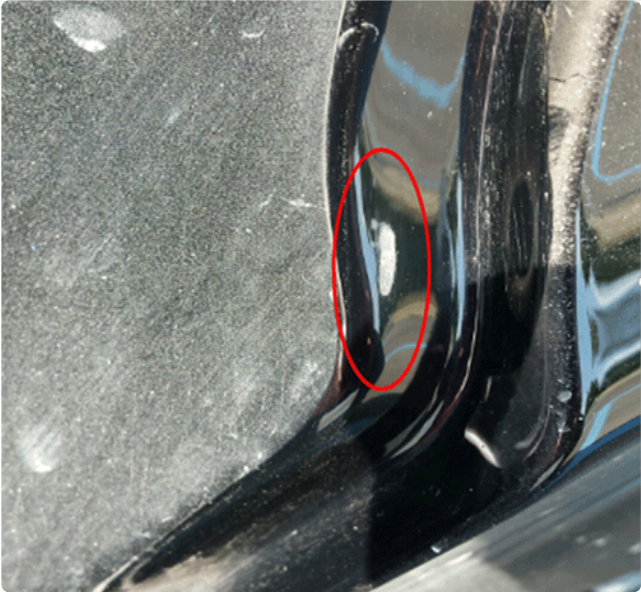
<p>Open In New Tab</p> <p>Zoom/Print</p> <p>Some customers may comment on a paint chip or wear mark (marring) on one, or both, of the rocker panel moldings. Several examples of the condition are shown in the graphics above.</p>
<p>Cause</p>	<p>Note: Adjusting the door WILL NOT resolve this issue.</p> <p>The cause of the condition may be because of a tight door hem sealer to rocker clearance, by design. The marring or chipping happens when the door makes contact with the rocker during door closure (over-slam). This is NOT a rub condition once the door is closed.</p>

Complete a partial paint repair to the rocker(s) to correct the condition.
