2018 Chevy Truck Silverado 1500 2WD V8-5.3L eAssist

Vehicle > Technical Service Bulletins

CLICK / RATTLE / TICK / POP / CREAK / OR SQUEAK NOISE FROM DASH AREA

#PIT5438E: Click / Rattle / Tick / Pop / Creak / or Squeak Noise from Dash Area - (Oct 29, 2018)**Subject: Click / Rattle / Tick / Pop / Creak / or Squeak Noise from Dash Area**

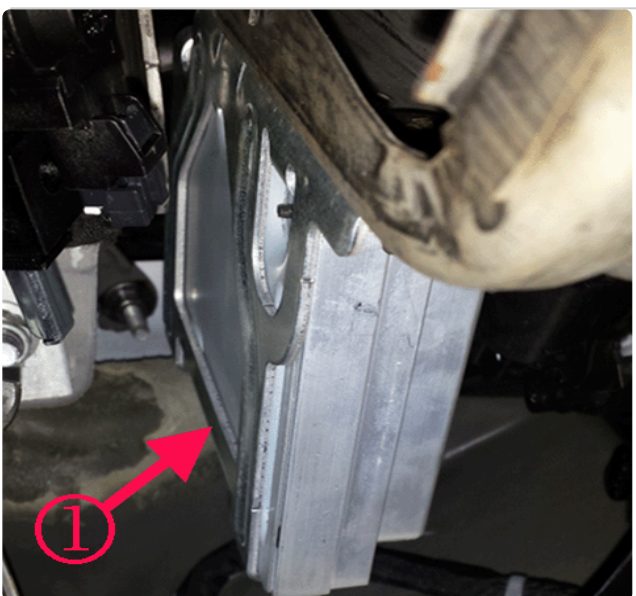
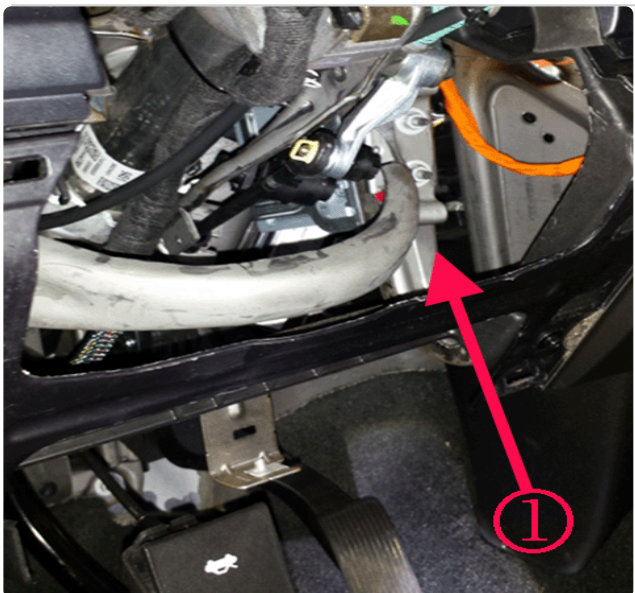
Condition 1: Tinny or metallic rattle type noise from the IP area to the left of the steering column.

The noise may be caused by the 110 Volt Power Inverter Module not being seated properly in the mounting bracket (if equipped with RPO K14).

Inspect the power inverter module for possibly moving slightly against mounting bracket and creating the noise.

Follow SI to locate the Accessory AC and DC Power Control Module located to the right of the steering column.

See #1 in photos below:

Remove the K14 power inverter module and apply two sided tape to the module bracket to insulate it from the mount.

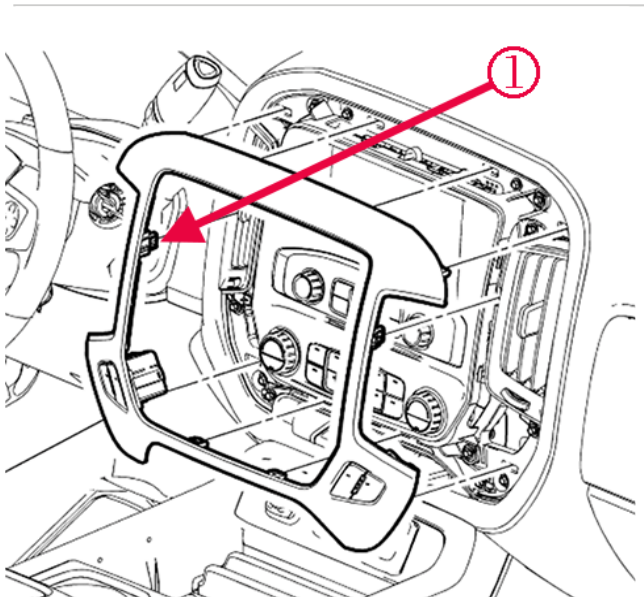
Condition 2: Rattle, squeak or itch type noise from the center of the dash in the radio area.

The instrument panel accessory bezel may be rattling due to insufficient tension of retainers. Press on the bezel while duplicating noise to see if it is eliminated.

Wrap Kent automotive BRS flocking tape part number KT13487 over retainers (#1 in illustration) and reinstall bezel.

This will require an application of BRS flocking tape on ten retainers (one strip @ 1" x 10"). Two sheets should repair 16 vehicles.

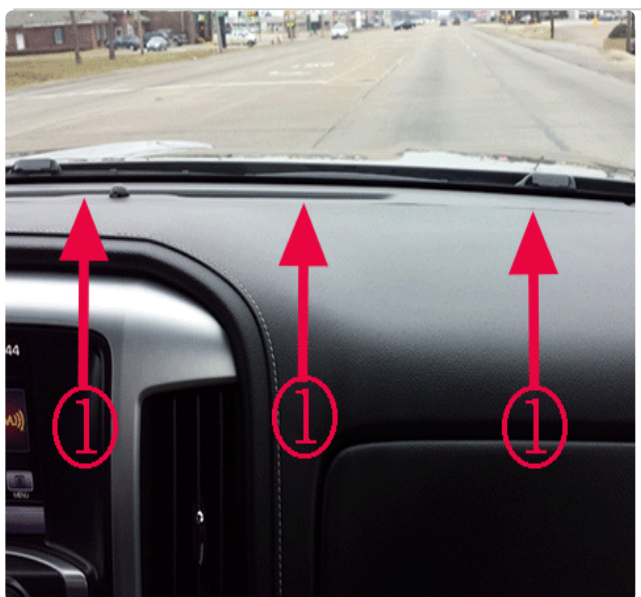
Condition 3: Rattle or itch type noise from the dash area near the windshield

Defroster grill may be rattling due to insufficient retention of retainers. Press on defroster grill (# 1 in illustration) while duplicating concern to see if it is eliminated.

Remove defroster grill.

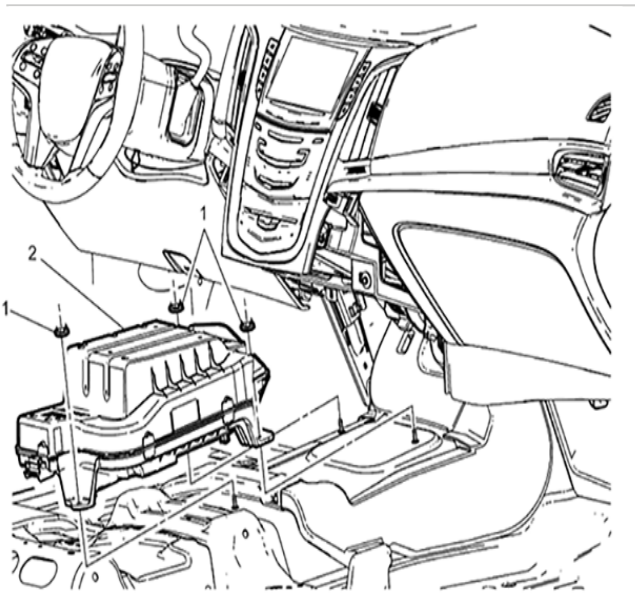
Condition 4: Rattle, tick, knock type noise from the front center floor or center of dash area (Applies to trucks equipped with center console subwoofer speaker)

This concern could be caused by the radio subwoofer speaker mounting nuts either being loose or missing.

To correct this issue, inspect the center console subwoofer speaker (2) mounting nuts (1) for being loose or missing. Subwoofer speaker mounting is shown below. Install and tighten the subwoofer speaker mounting nut(s) to 6 Nm (53 lb in).

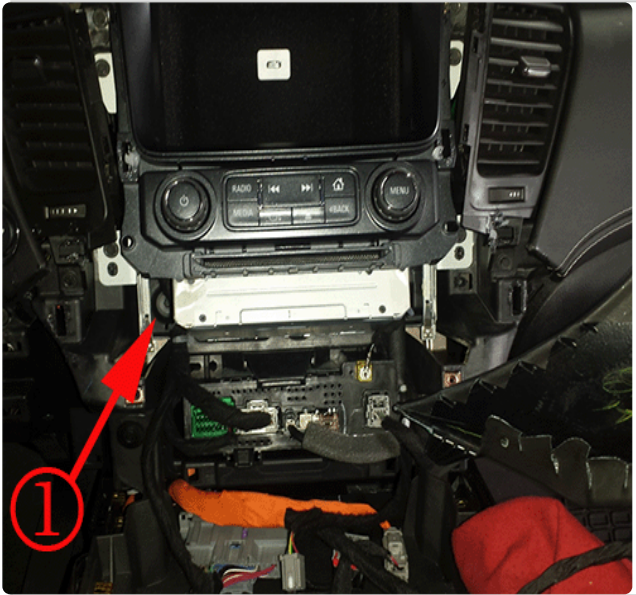
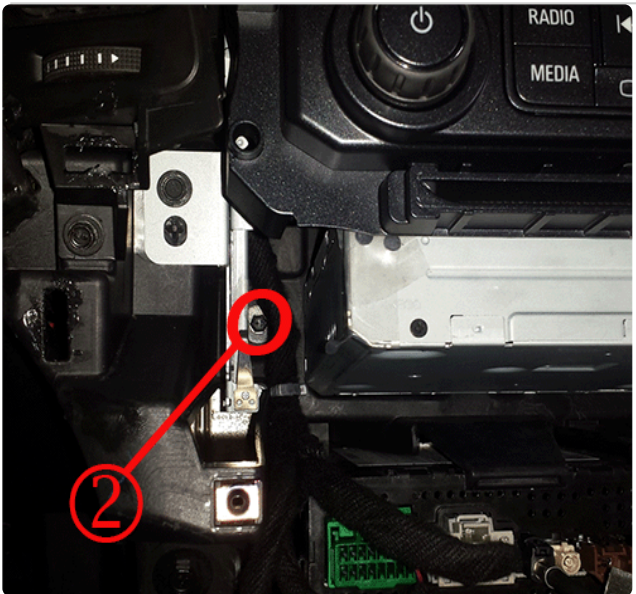
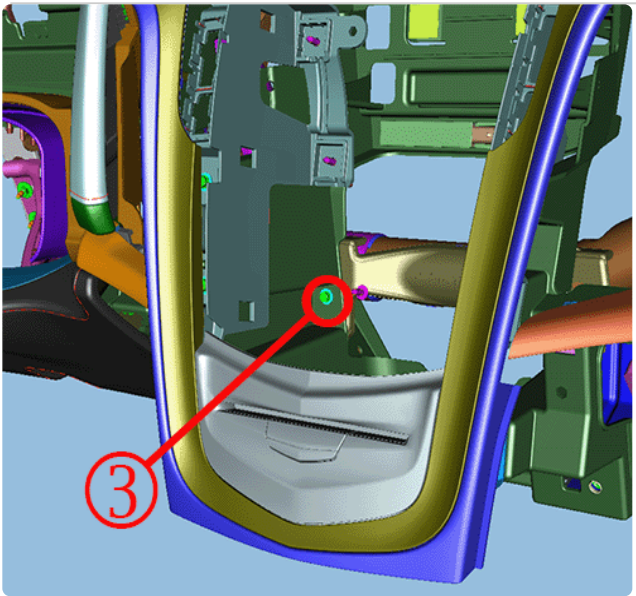
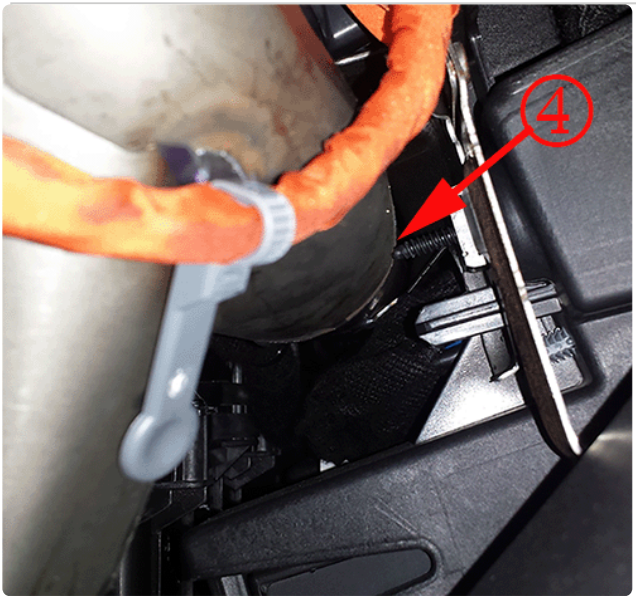
Condition 5: Creak, ticking or popping type noise heard from the left center stack area. (This issue only applies to Full Size Utilities built before November 18, 2016)

This concern could be caused by the use of an incorrect screw that secures the instrument panel carrier in place.

The screw that may have been used is too long, and it may contact the instrument panel tie bar. In some cases, this noise may only occur after the vehicle has been driven for a period of time.

The screw shown in the photos below may be too long and the screw tip actually contacts the instrument panel tie bar. This contact is shown as item #4 below. This screw secures the instrument panel carrier to the instrument panel tie bar.

Chevrolet/GMC models are shown as item# 1 and a close-up of this fastener can be seen as item #2. Replace this screw with a shorter fastener, GM part number 11547755, which is approximately 24 mm in length.

Cadillac models can be seen in item #3 below. Replace this screw with a shorter fastener, GM part number 11547755, which is approximately 24 mm in length as well.

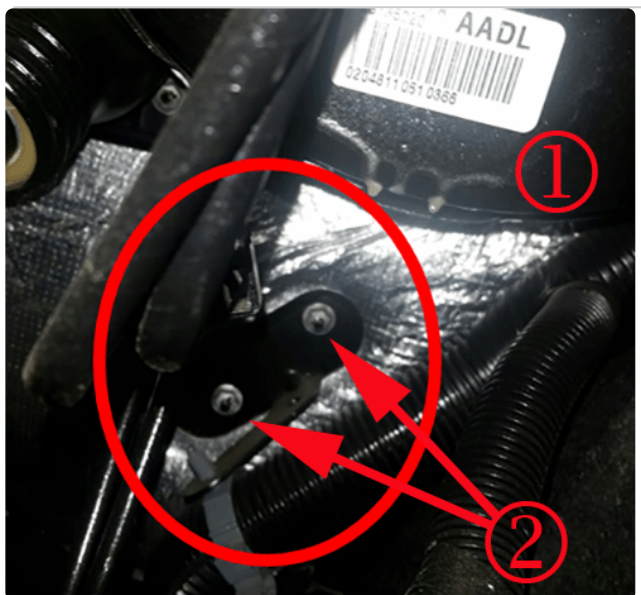
Condition 6: Chirp or squeak noise coming from the lower left side of the center stack area.

This concern could be caused by loose retaining nuts on the chassis harness retention bracket that is located below the brake booster.

The following picture shows the chassis harness retaining bracket and nuts (2) below the brake booster (1). Verify the retaining nuts are tight.
