#15708: Customer Satisfaction - Water Leak onto Left Cabin Floor - (Nov 19, 2015)

Subject: 15708 - Water Leak onto the Left Cabin Floor

Models: 2016 Chevrolet Colorado

2016 GMC Canyon

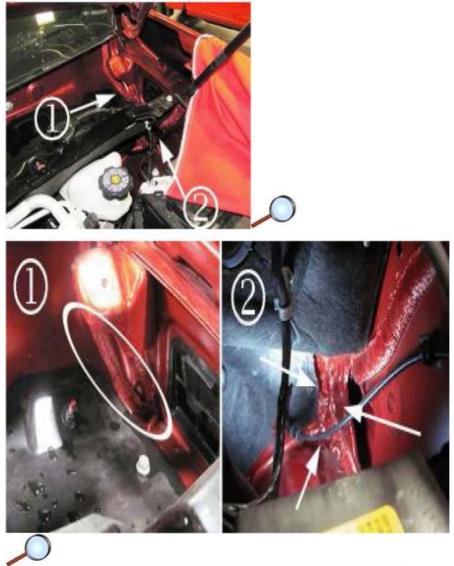
Certain 2016 model year Chevrolet Colorado and GMC Canyon model vehicles may have a condition in which an improperly sealed vertical seam near the driver's side dash may cause water to leak onto the driver side cabin floor. This can result in wet carpets or a mildew smell.

5. Apply seam sealer to the above (1) and the below (2) seams as shown above.
