2018 Chevy Truck Silverado 1500 2WD V8-5.3L eAssist

## DIAGNOSTIC TIP: WHISTLE NOISE FROM INSIDE VEHICLE

**#PIT5272B: Diagnostic Tip: Whistle Noise from Inside Vehicle - (Nov 13, 2018)****Subject: Diagnostic Tip: Whistle Noise from Inside Vehicle**

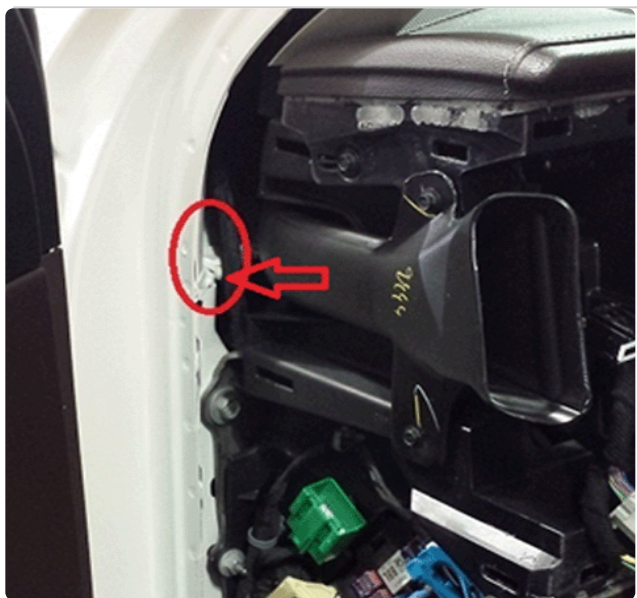
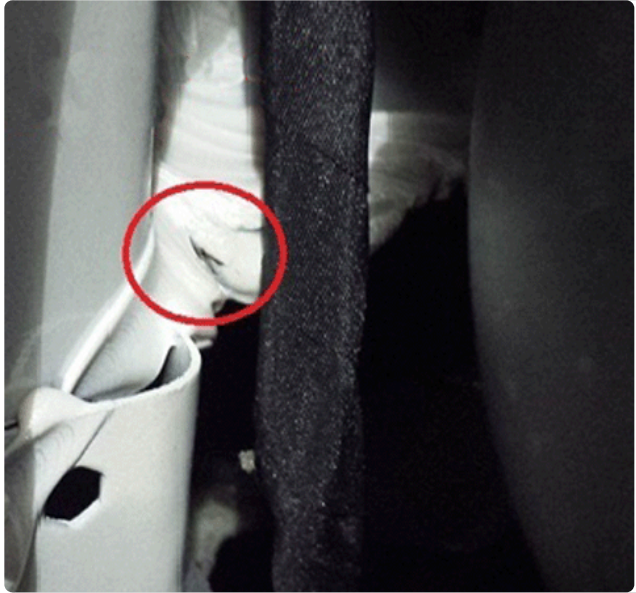
Some customers may comment there is a whistle noise in the vehicle from the driver or passenger side. Some may also state this is present while driving or with the HVAC on and in recirculation mode or the noise will go away or change if HVAC is switched out of recirc, or if a window is cracked open. This could be caused by voids in the body sealer in one or more places.

1. It may be helpful to use a hose as a listening aid to be able to tuck it down along the corners of the IP behind trim to get closer to the source of the noise to help pinpoint areas for focused inspection
2. Inspect for voids in the body sealer on the left or right side A-pillar as shown in the pictures below.
  - A.) It may be necessary to remove the Front Door Body Side Weatherstrip to gain access to the lower A-Pillar to cowl seams.

3. If voids are found in the A-pillar sealer, repair the voids and retest.
4. If no voids at the A-pillar were identified or if repair of voids did not completely eliminate issue, inspect for voids in the body sealer at the cowl seam under Air Inlet Grille (wiper plenum) Panel on the left side as in the picture below.

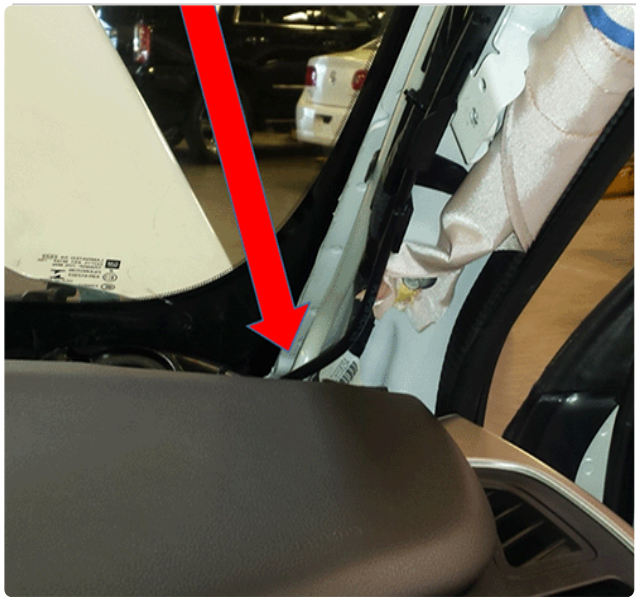
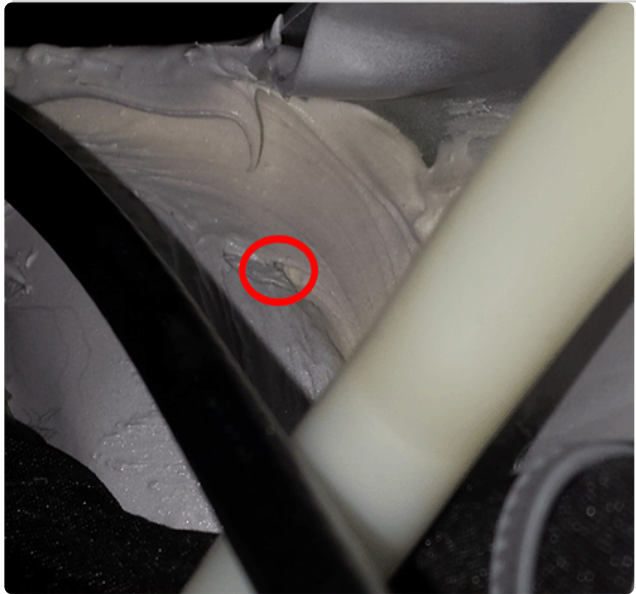
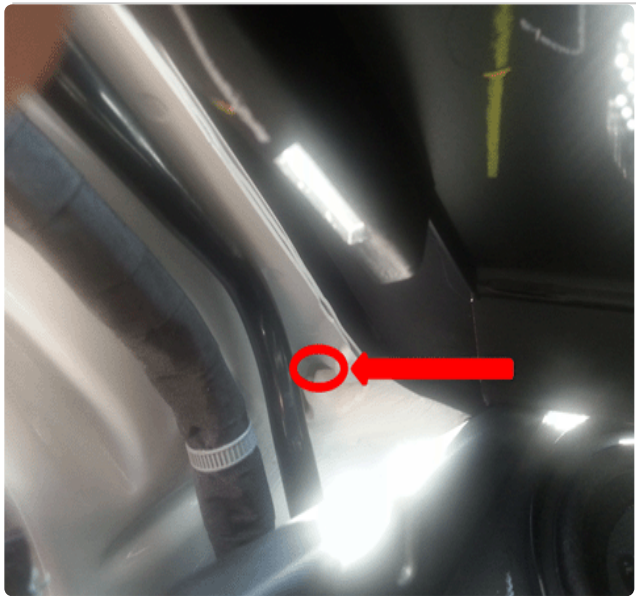
B.) When looking at the base of the left or right A-Pillar to cowl, it may be necessary to look in through the windshield to locate the missing sealer.

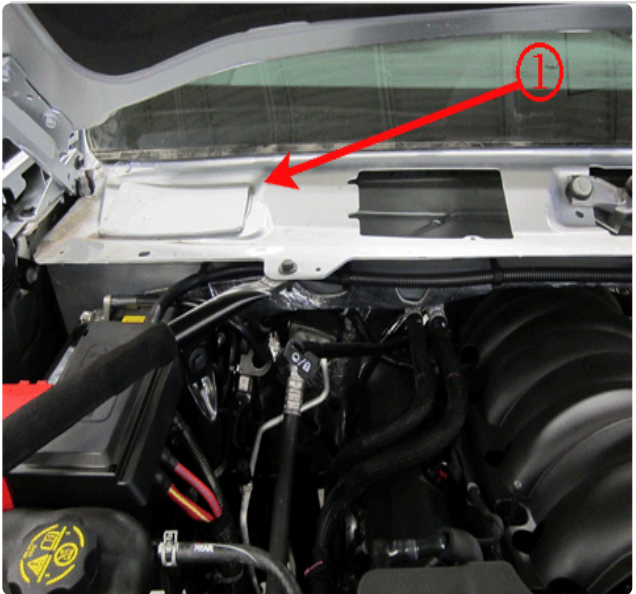
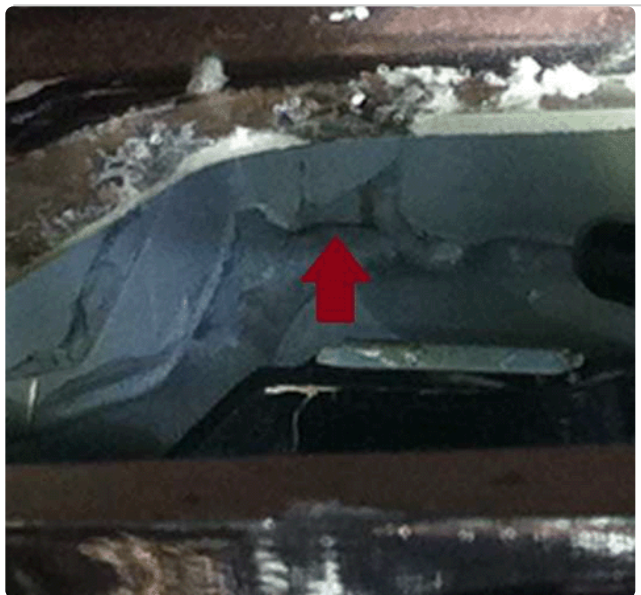
5. Inspect for voids in the body sealer at the cowl seam on the right side under the plenum cover cap as shown in the picture below.

**Note:** The plenum cover cap (1) must be removed and resealed to perform this inspection.
